# Condition assessment of an 8-year old Freeway bridge, its load capacity and rehabilitation assessment

*Ahmad Shayan\* and Fred Andrews-Phaedonos†*

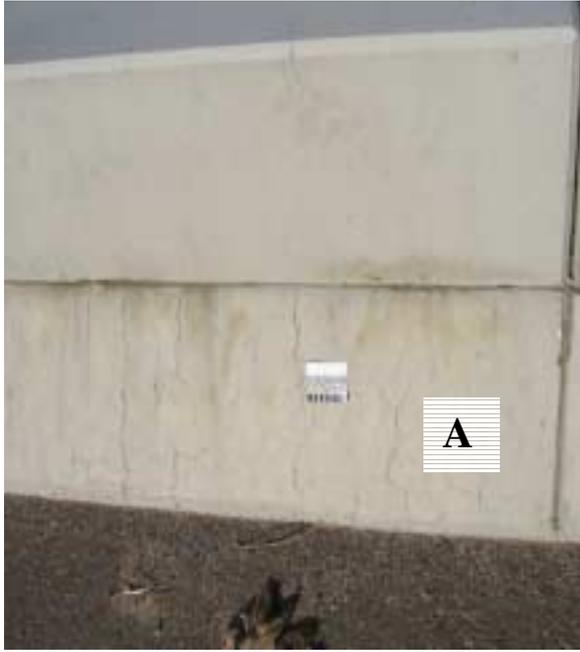
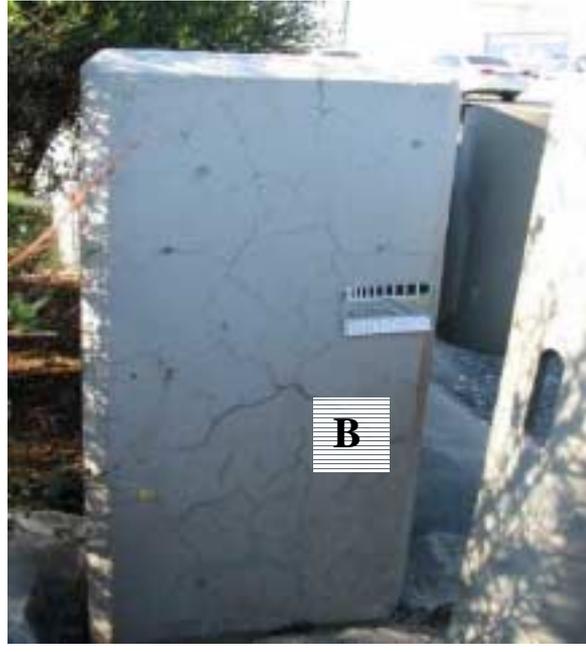
Viewed from the top of the deck, the base of all the parapet units show considerable cracking. The cracking is more extensive in the base of the unit, which is cast in-situ, rather than in the upper part which is precast. Posts at the end of the parapets also show this type of cracking. Typical views are shown in Figure 4. The cracking could have been caused by a single problem, or a combination of problems, including thermal cracking, drying shrinkage, alkali-aggregate-reaction (AAR) and delayed ettringite formation (DEF), but in this case a physical reason may be more likely than AAR and DEF.

*Figure 4: Cracking in the base of the parapet unit (4A) and in a post (4B).*

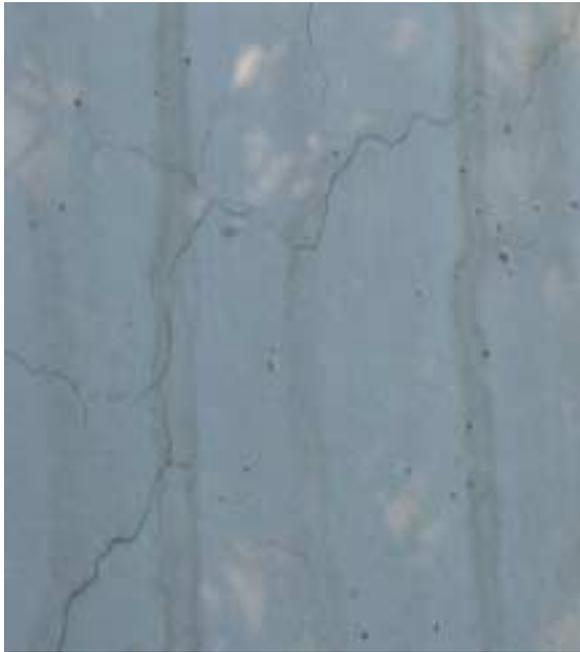
The north and south faces of both abutments consist of 300 mm thick concrete walls, which show considerable random cracking. The north wall of the east abutment has cracks of 0.1–0.2 mm width. These are likely to have been caused by drying shrinkage and/or AAR. The south abutment wall shows more directional cracking rather than map-cracking. Figure 5 shows this type of cracking.

*Figure 5: Cracking in the north wall of the east abutment.*

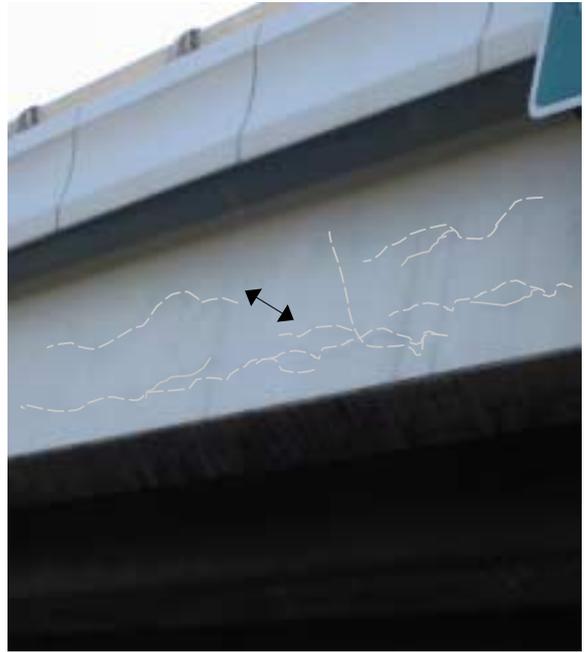
Only the exterior faces of the super T-beams at the two sides of the bridge (north and south) show parallel longitudinal cracking. These could have been caused by the factors mentioned earlier. Figure 6 shows examples of this type of cracking. In one location (east end of the southernmost beam of mid span) faint cracking, which may be due to loading, was noted, as seen in Figure 7. The interior beams appear to be in good condition. However, in some locations on the west abutment side of the Centre Bridge, damage to the beams (braking/cracking), must have occurred due to mishandling during installation or impact by heavy vehicles, and water leakage has occurred through such cracks (Figure 8).

*Figure 6: Longitudinal parallel cracking on the exterior face of the southern-most beam of the middle span.*

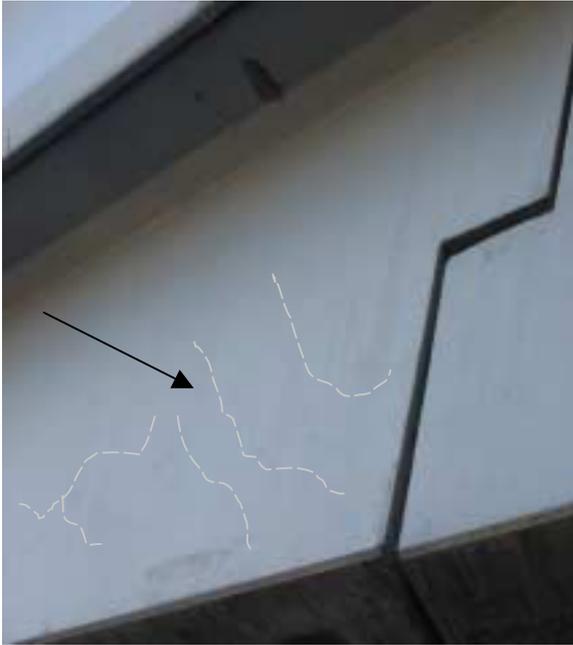
**Figure 7:** Weak radial cracking at the lower corner of the left beam (southernmost beam, middle span).

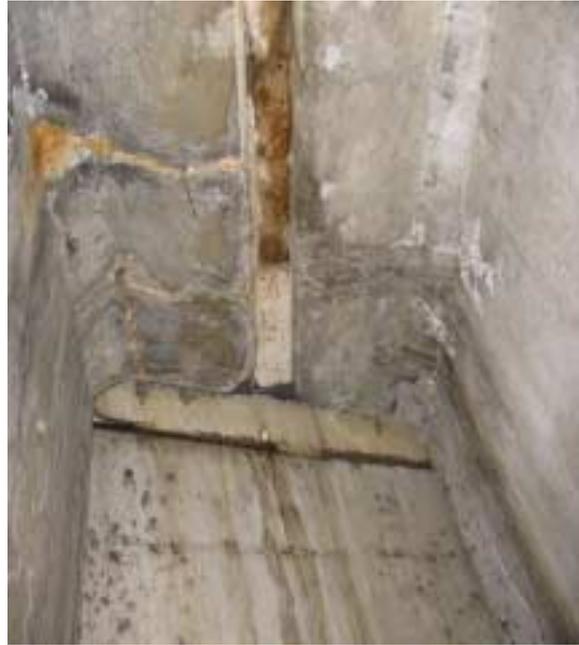
**Figure 8:** Cracking in the flange of some super T-Beams at the left abutment, probably resulting from mishandling or impact by heavy vehicles.

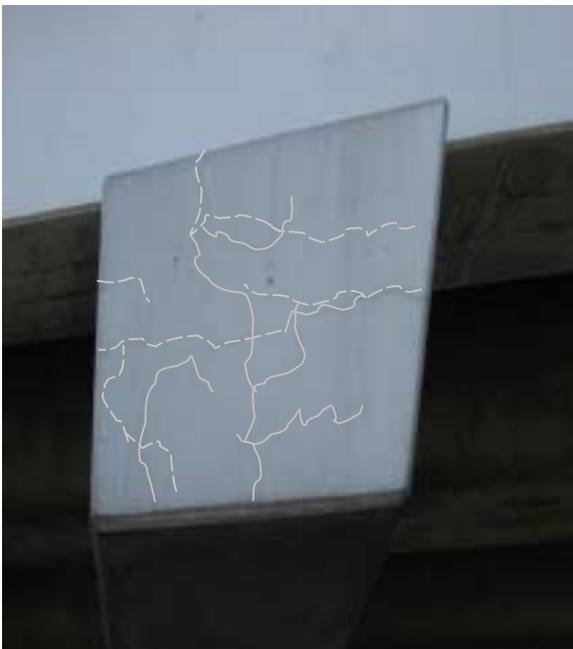
Two types of cracking are noted in the crossheads. The exposed ends of the crossheads (i.e. north facing end of the North Bridge crosshead, and south facing end of the South Bridge crosshead) show map cracking that extends into the body of the crosshead. This is very typical of AAR, but could also have arisen from drying-shrinkage (Figure 9). The crossheads in Pier 2 show more obvious cracking than Pier 1. The other type of cracking

**Figure 9:** Map-cracking at the south end of the south bridge crosshead. Cracking extends into the element.

1. Strengthening of the crossheads particularly in the cantilever section by either of steel plating, carbon fibre composite system, installation of additional supports or external post-tensioning.
2. Repair vertical cracks in columns and map cracking in crossheads by epoxy injection and maintain the existing surface coating of all the elements.
3. Repair shrinkage cracks in abutment walls and Pier 1 pile cap by epoxy injection and application of an anti-carbonation coating.
4. Examine concrete core samples from the precast T-beams and barrier units and verify the cause of cracking of the exterior faces of the edge beams and of the precast barrier units, and treat them accordingly.
5. Undertake sampling and testing of substructure for AAR in 5 years time.

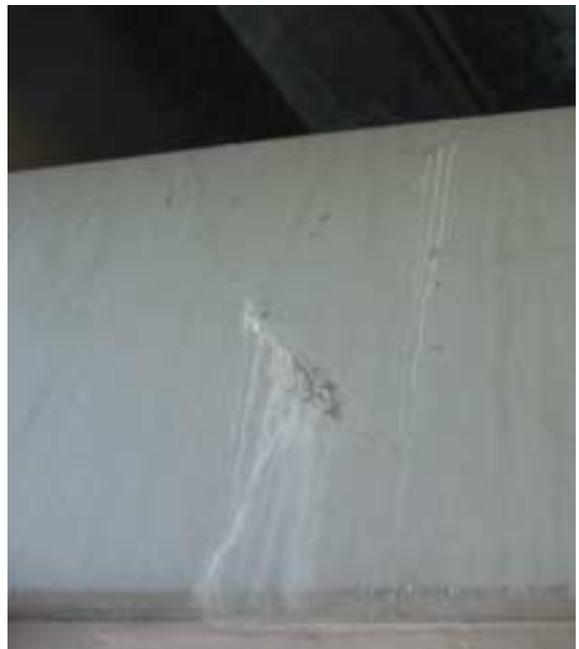
appears to be similar to shear-cracking and is evident near the supports in most of the crossheads (Figure 10).

The crossheads, however, were found to have insufficient load capacity against T-44 and SM1600 loading, requiring an additional 33% tensile steel for the cantilever to resist the bending moment. The mid-span would require 16.6% more steel reinforcement at the top compared to the current configuration. The observed structural cracking of the crossheads could be explained by insufficient load capacity. It appears that other factors have contributed to the development of non-structural cracking in the crosshead ends, and to the cracking of columns and the edge beams.

**Figure 10:** Close up of a shear crack in the crosshead.

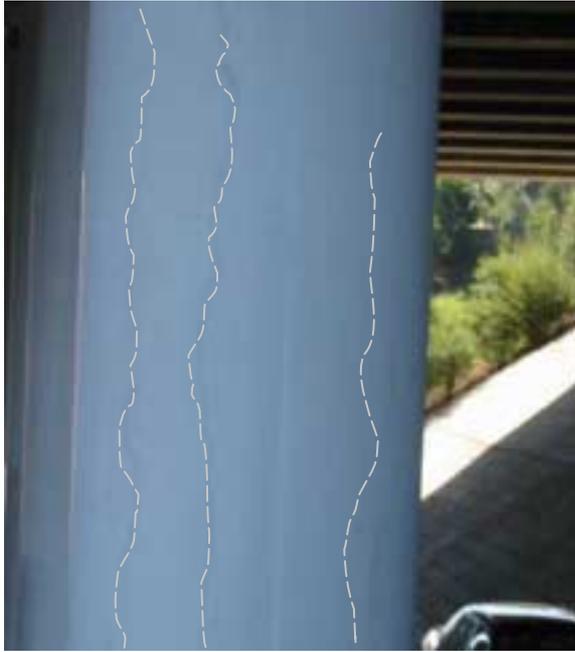
Vertical cracking is present in columns of both piers in all the 3 bridges, but it is more extensive towards the southern end of the piers. In some columns there are multiple parallel cracks of 0.2–0.3 mm width (south columns of the South Bridge in both piers), and some other columns exhibit one or two narrower vertical cracks. Examples of these cracks are shown in Figure 11. The cracking in the columns of the Centre Bridge is much less extensive than those shown above.

found to be adequate, and the observed cracking at the exterior faces of the edge beams could not be explained by insufficient load capacity. The columns were also found to have sufficient load capacity but they are currently experiencing stresses up to 80% of their load capacity, indicating that the parallel vertical cracking is probably unrelated to mechanical loading. It would be better to improve the load capacity of the columns such that current loading does not exceed 60% of the load capacity.

***Figure 11: Multiple parallel vertical cracking in the southern-most column of Pier 2.***

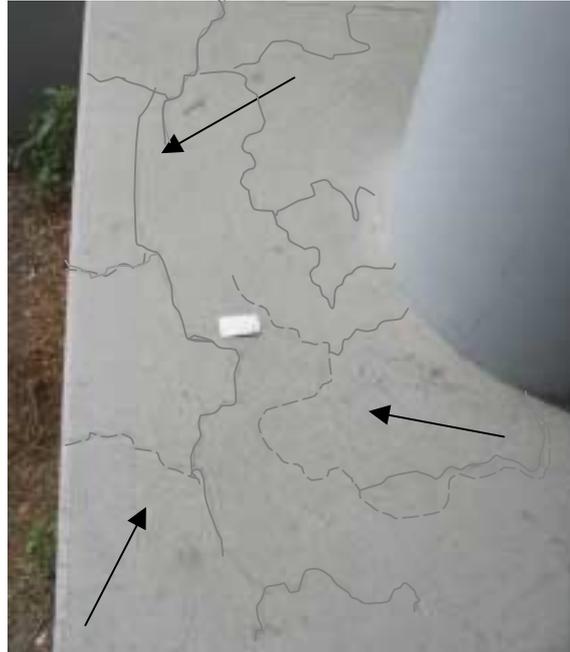
The pile caps of Piers 1 and 2 are continuous for all the 3 bridges. The pile cap of Pier 2 is level with the footpath and not visible, but Pier 1 pile cap is raised and shows extensive map-cracking, particularly at the south and north ends (Figure 12). The middle section is relatively free of cracking. This cracking appears very likely to be due to drying-shrinkage, but ARR cannot be discounted. The cracking will increase the carbonation rate of the concrete if it remains untreated. Small roadside walls alongside the pile caps also show similar features (Figure 14).

***Figure 12: Map-cracking in the north end of pile cap of Pier 1, probably due to drying-shrinkage.***

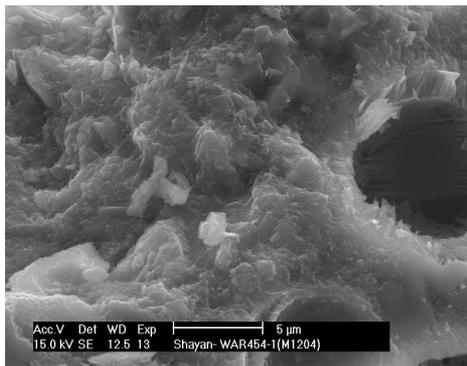
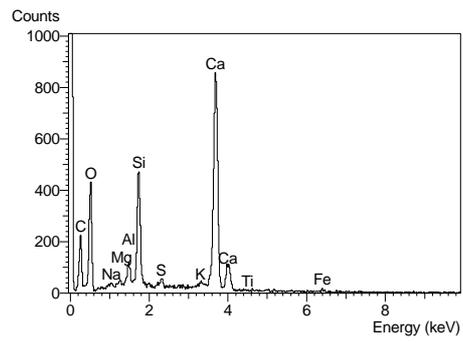
The hydrated cement phase was found to be enriched in Si and Al, compared to the usual calcium-silicate hydrate (CSH) produced as a result of hydration of ordinary Portland cement. This was very likely due to the incorporation of fly ash in the concrete, and Figure 13 shows the composition of the paste in the vicinity of two sites of reacted fly ash particles (round

**Figure 13: View of hydrated cement paste and its composition represented by the EDX spectrum**

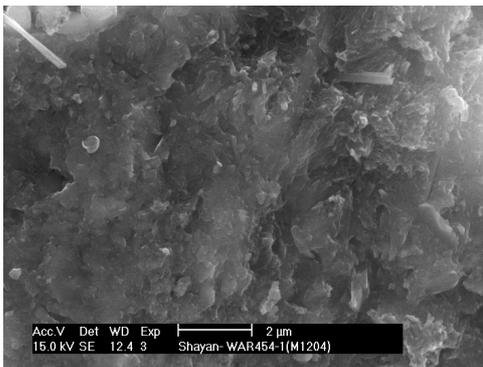
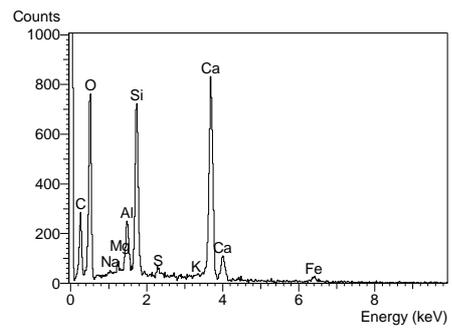
features to the right). More significant enrichment of the paste with Si and Al are seen in Figures 14 and 15. Although the aggregate exhibited petrographic features of a reactive aggregate, the incorporation of fly ash appears to have prevented the occurrence of AAR. Moreover, the composition of the cement paste indicate very little alkali to be present, and this may be another reason why the aggregate has not exhibited signs of AAR. (As mentioned earlier, it would be too early for this to have happened on a large scale).

**Figure 14: SEM view of paste enriched with Si from fly ash and its EDX spectrum**

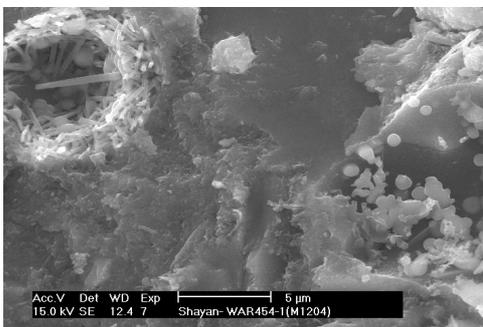
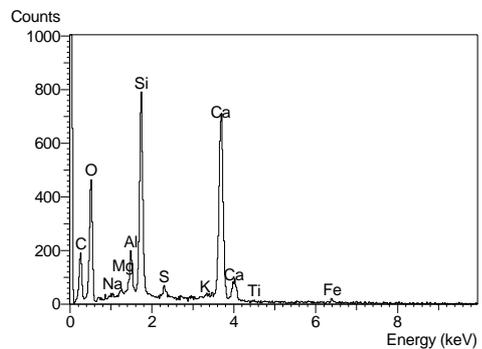
**Figure 15: SEM view of another area showing enrichment with Si, and its EDX spectrum**

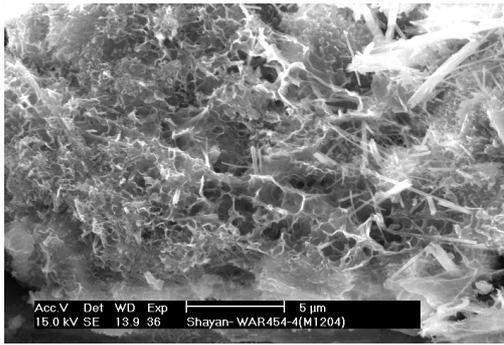
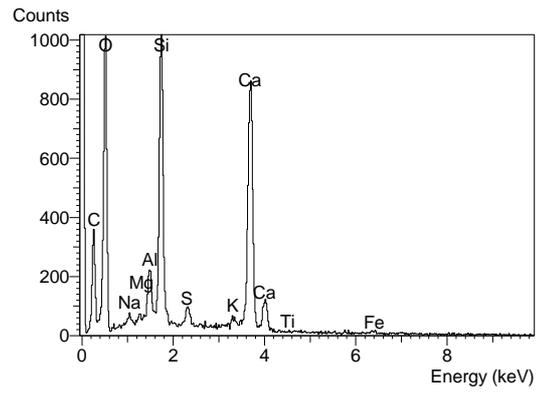
Porous areas were observed in some locations (Figure 16), in which the cement paste was also enriched in Si, but crystals of ettringite had also grown in the open spaces. This may have occurred due to localised high water/cement ratios in these regions.

***Figure 16: Porous area in cement paste probably indicating zone of high water content. The paste is enriched in Si.***
