# Condition assessment of an 8-year old Freeway bridge, its load capacity and rehabilitation assessment

*Ahmad Shayan\* and Fred Andrews-Phaedonos†*

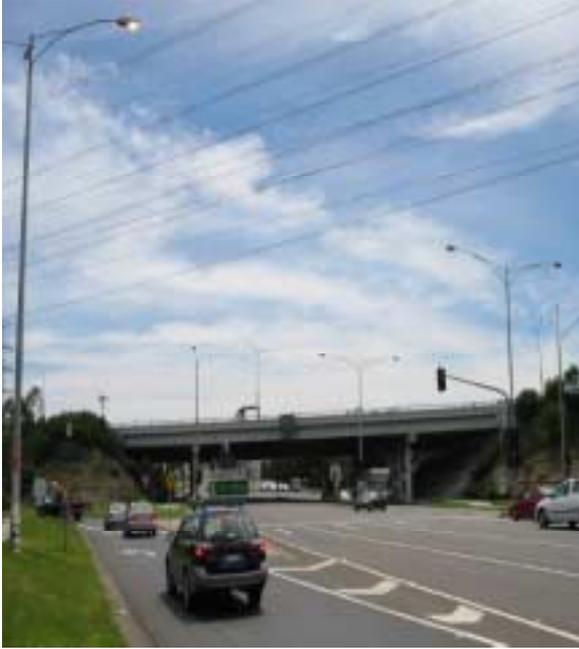
*Figure 1a: General view of bridge from the south. Melbourne CBD is to the left.*

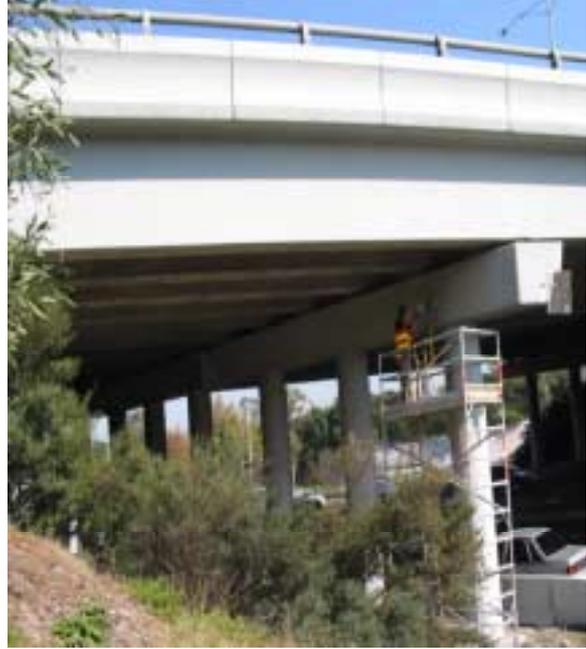
*Figure 1b: Pier 2 from which cores were taken, viewed from the North.*

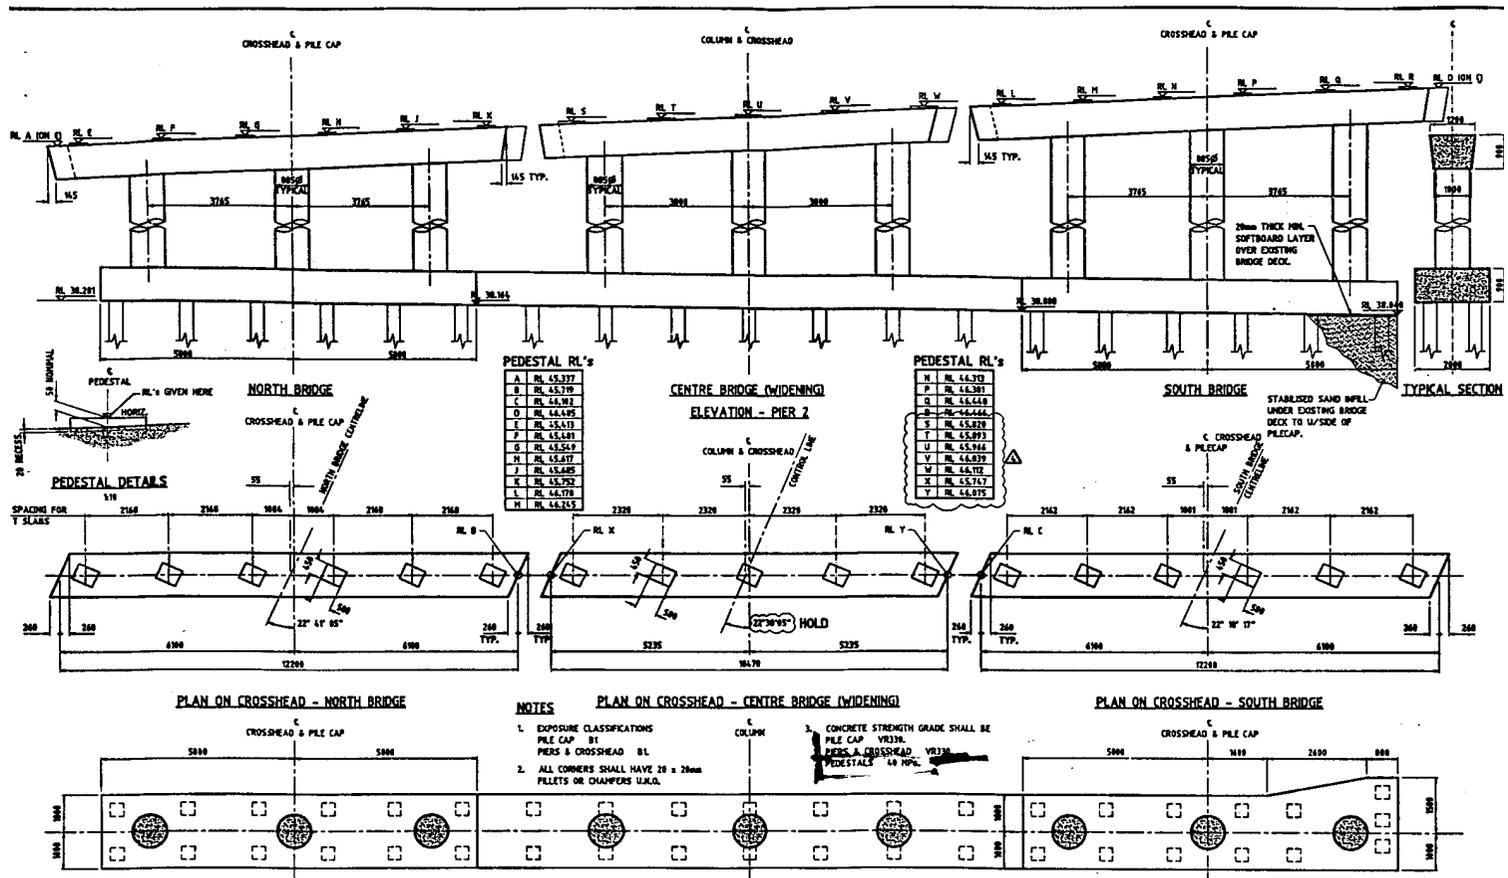
Figure 2: Cross section of structure at Pier 2, showing individual piers for North (left), Centre and South (right) bridges

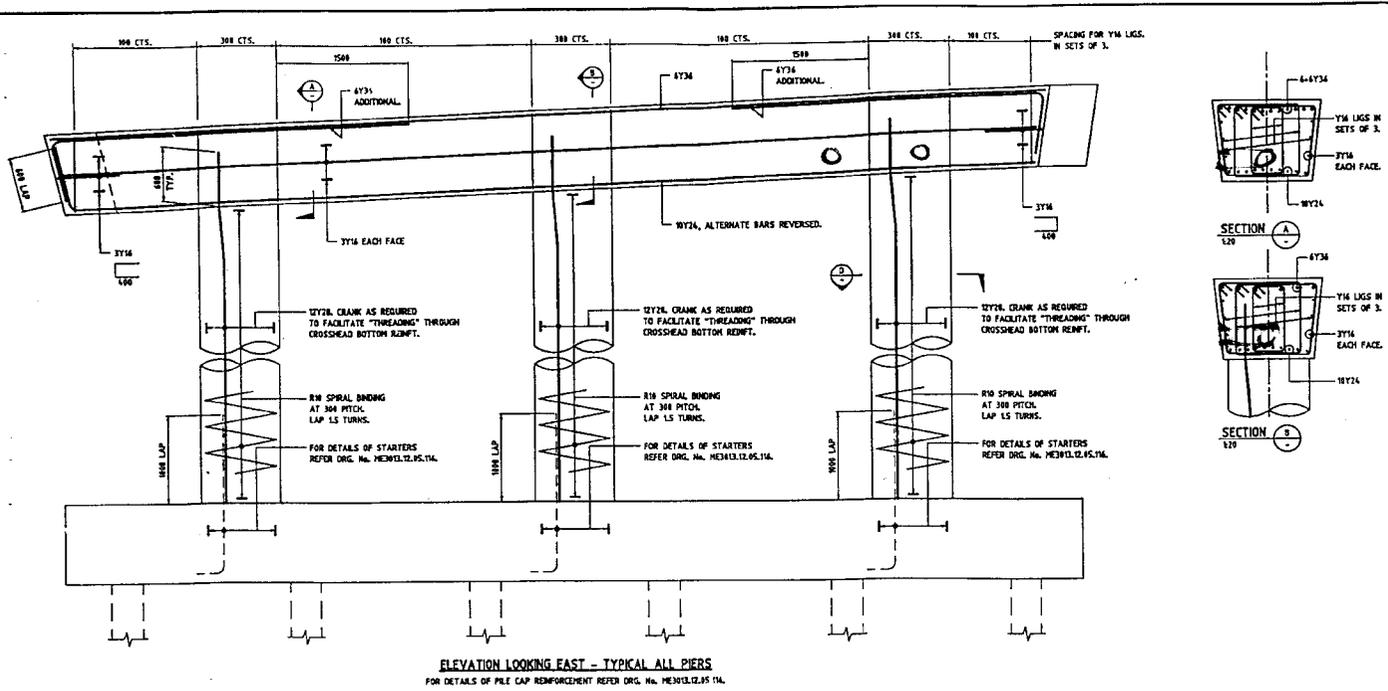
Figure 3: Typical Pier configuration

The crossheads, however, were found to have insufficient load capacity against T-44 and SM1600 loading, requiring an additional 33% tensile steel for the cantilever to resist the bending moment. The mid-span would require 16.6% more steel reinforcement at the top compared to the current configuration. The observed structural cracking of the crossheads could be explained by insufficient load capacity. It appears that other factors have contributed to the development of non-structural cracking in the crosshead ends, and to the cracking of columns and the edge beams.

1. Strengthening of the crossheads particularly in the cantilever section by either of steel plating, carbon fibre composite system, installation of additional supports or external post-tensioning.
2. Repair vertical cracks in columns and map cracking in crossheads by epoxy injection and maintain the existing surface coating of all the elements.
3. Repair shrinkage cracks in abutment walls and Pier 1 pile cap by epoxy injection and application of an anti-carbonation coating.
4. Examine concrete core samples from the precast T-beams and barrier units and verify the cause of cracking of the exterior faces of the edge beams and of the precast barrier units, and treat them accordingly.
5. Undertake sampling and testing of substructure for AAR in 5 years time.
